Saint Paul Public Library

Hamline Midway Library

Pre-Design Report

May 13, 2022

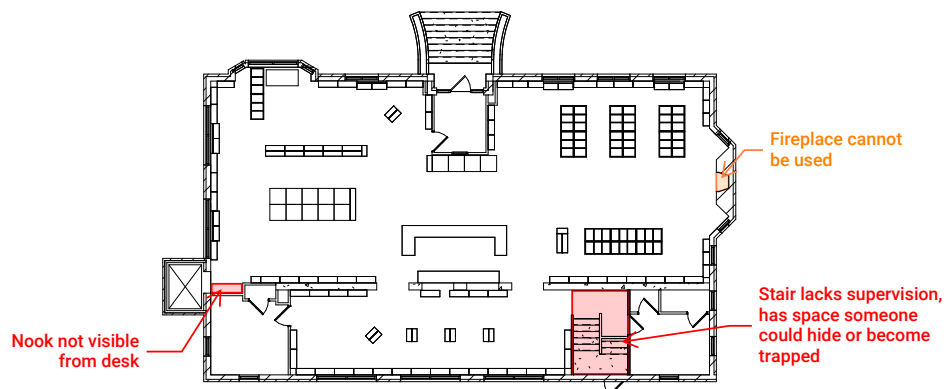
Lower level hallways are not accessible and inadequate as public spaces. Hallway from accessible entry to toilets is too narrow for passing, and hallway behind stage is a dead end corridor not visible from any other spaces and could allow someone to hide or trap someone.

Lower level dead end corridor

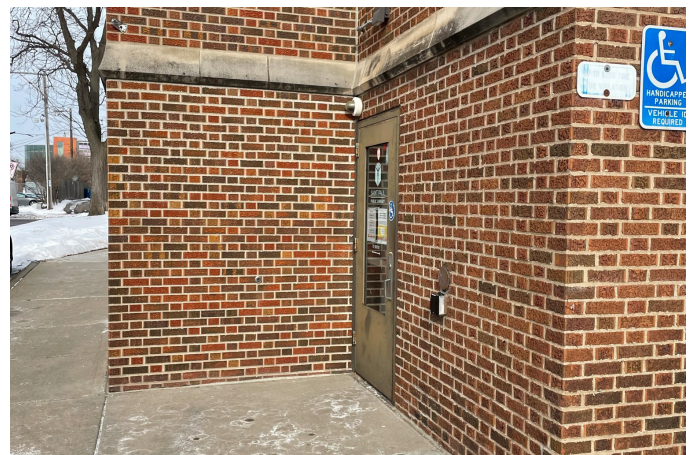
Accessible Entrance

Accessible entrance is not the main entrance and is significantly inferior to the entry stairs. Accessible entrance leads into the lower level and requires an elevator to a drop off at the back corner of the main reading room where the main entry is visible from the street and enters into the center of the main reading room.

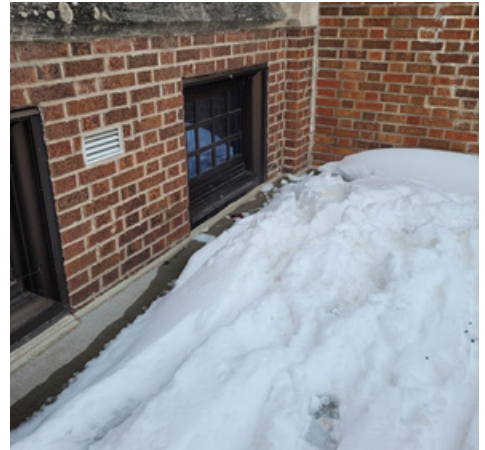
Snow at front entry window

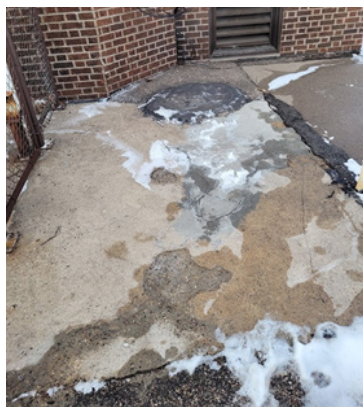
Deteriorated Concrete at Transformer

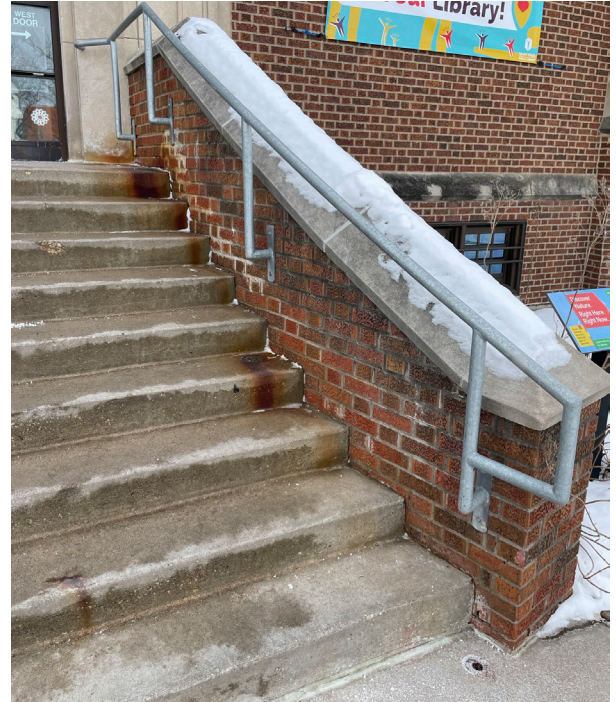
Entry stair was replaced in the 1980s but is in poor conditions. Stair risers are concrete and have chipped. Masonry shows signs of deterioration. Railing was previously removed and post embeds rusted and have stained stairs. Stairs should be demolished and replaced.

Deterioration at entry stair

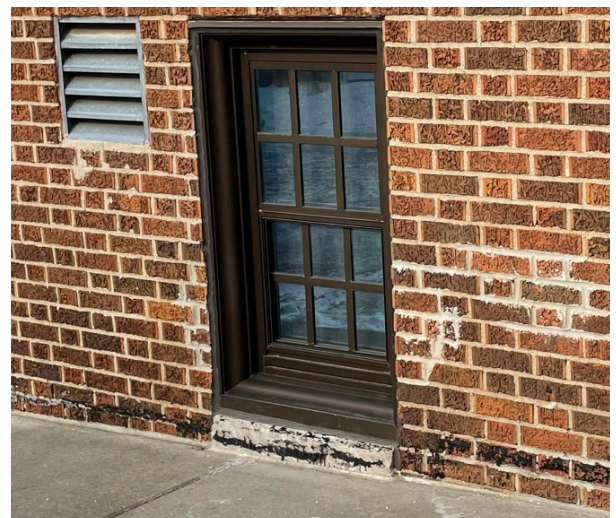
Grade at windows

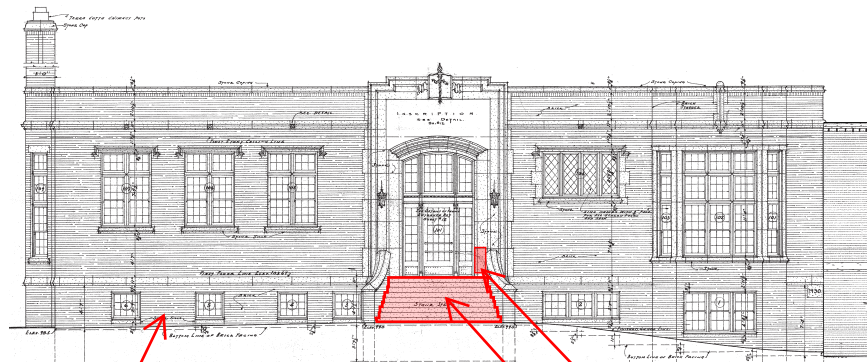
NORTH ELEVATION

Evidence of water infiltration

Stone spalling

Concrete steps and stone chipped and stained due to embeds rusting.

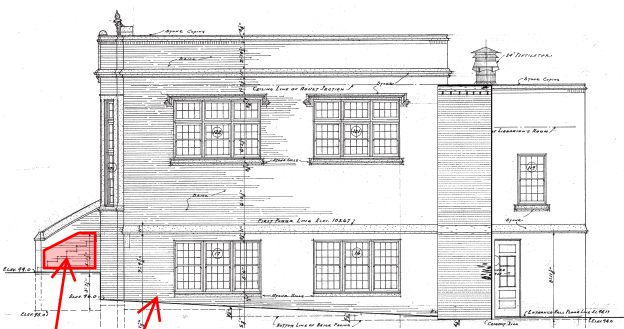
WEST ELEVATION

Evidence of water infiltration

Masonry damage and evidence of water infiltration

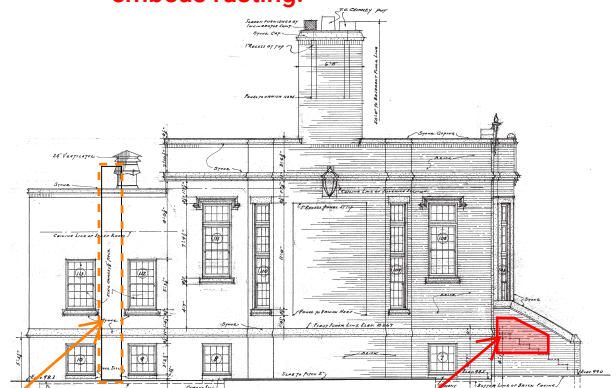
EAST ELEVATION

Roof ladder provides unauthorized access to the roof and is an unsafe condition. First several rungs are covered however uncovered rungs are within reach for most adults.

Ladder provides unauthorized access to roof

Masonry damage and evidence of water infiltration

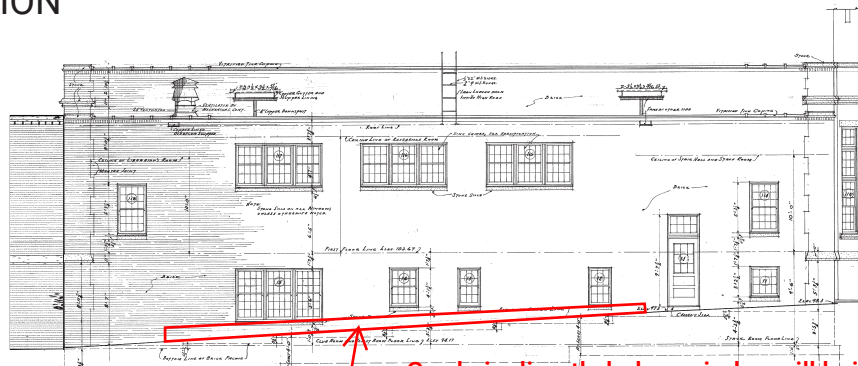
SOUTH ELEVATION

Foundation has no drain tile or waterproofing and interior has significant evidence of water infiltration that has damaged foundation wall.

Grade is directly below window sill height, not protected from parking lot. Wall below grade lacks drain tile and waterproofing leading to water infiltration.

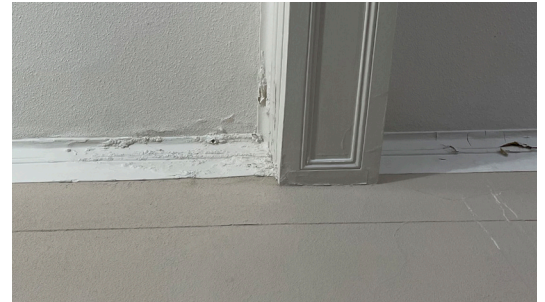
Ceilings and walls in main reading room have several areas of water damage, ceiling in Hamline Midway Coalition space shows signs of water damage. Walls through show signs of wear and require touch ups throughout. Walls in multipurpose room show significant water damage. The majority of trim and built-in casework is in OK condition.

Ceiling Plaster Damage in Reading Room

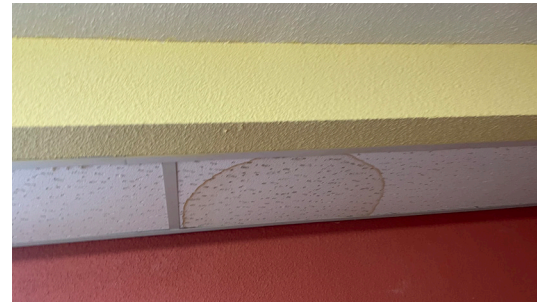
Ceiling Water Damage in Hamline Midway Coalition Office

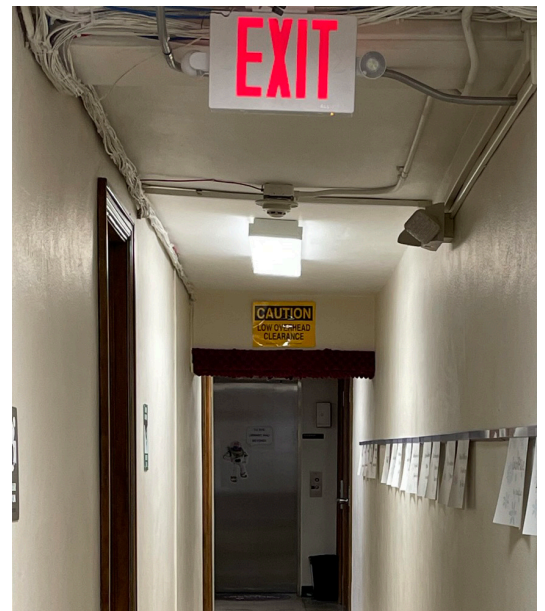
Exposed Wires at Ceiling and Low Structure in Hallway

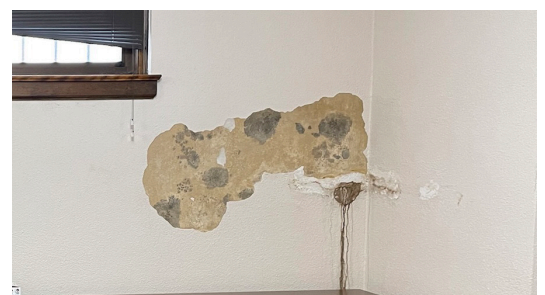
Wall Damage at Meeting Room

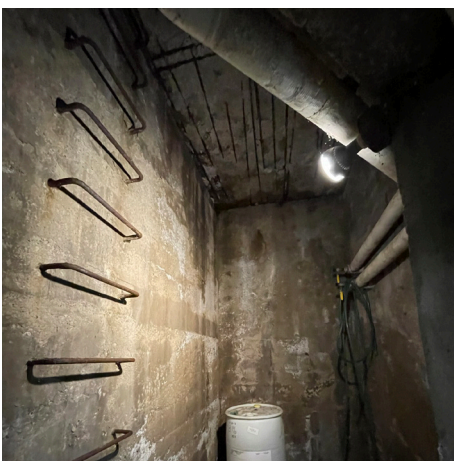
Inside the original fuel room and ash room on the east side of the building there is significant deterioration on the underside of the concrete slab over these rooms, as well as signs of water infiltration. These rooms are located outside of the building footprint above. A piece of mechanical equipment is sitting on this slab. The existing reinforcing in the slab is visible, and there is corrosion of the existing rebar. See the attached photos. The concrete slabs over these rooms need to be repaired and/or removed

Exposed Rebar in slab

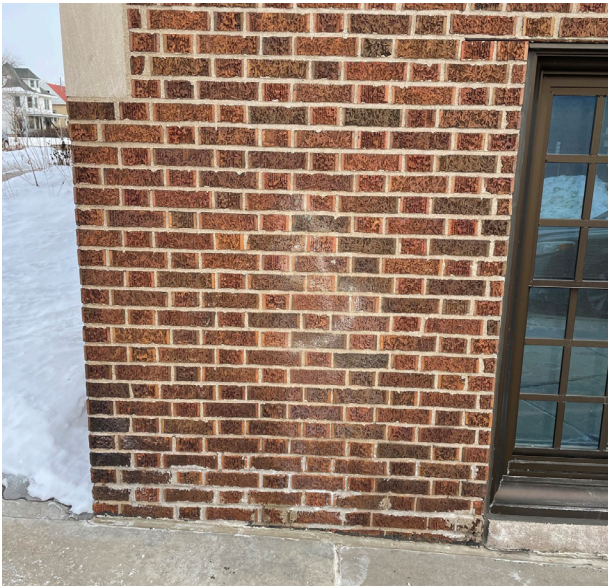
We did observe locations where the sidewalks abut the building where the joint should be caulked to prevent water seeping down this joint.

Sidewalk at building

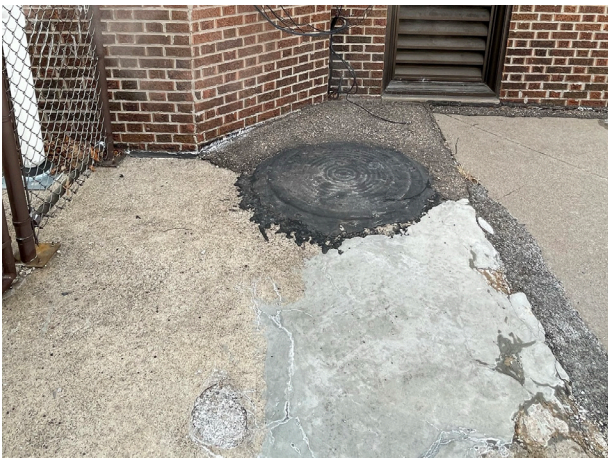
Exterior Slab degradation

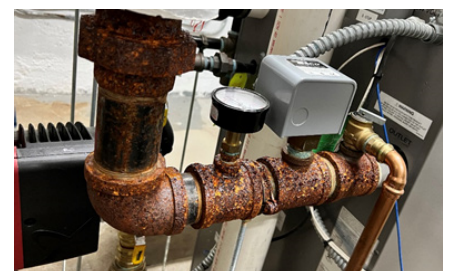
Figure 3: Boiler hydronic piping rust

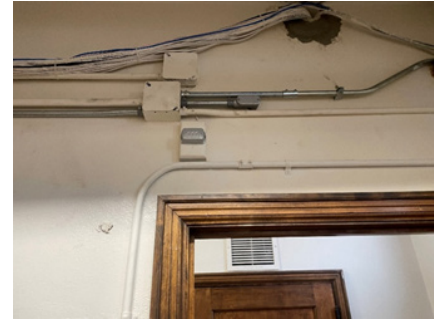
- Voice PABX is a Panasonic TVA50 system.
- Voice/data cabling is mostly Category 5/5e cabling.
- Wireless LAN coverage (WLAN) should be looked at for proper coverage.
- The voice/data jacks appeared to be in fair condition. Data cabling is not typically supported adequately with cabling zip-tied together or attached to conduit.
- The telecommunications lines enter the building from a utility pole at the south side of the building, and are routed on the surface of the building. This wiring is susceptible to damage. See Figure 12.

Figure 10: Exposed interior low voltage wiring

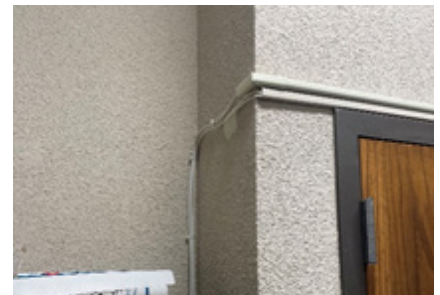
Figure 11: Exposed interior low voltage wiring and partially exposed raceway

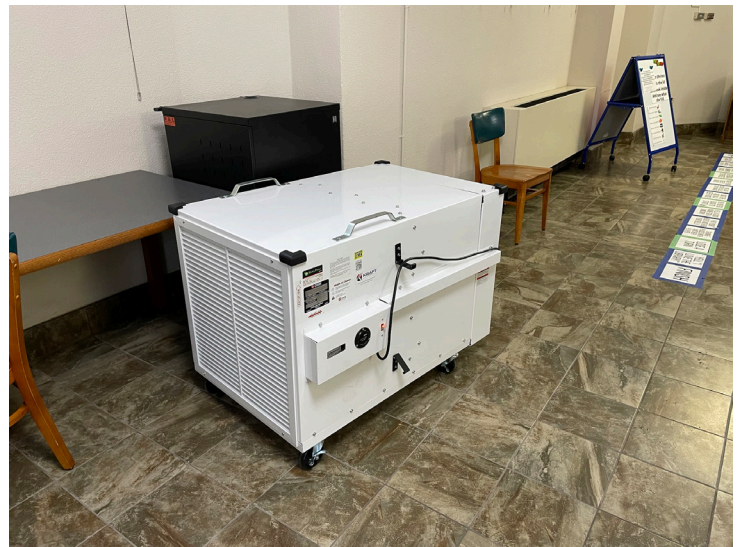
Temporary portable filter makes hearing presentations in auditorium difficult
