Saint Paul Public Library

HAYDEN HEIGHTS

Pre-Design Report

HAYDEN HEIGHTS LIBRARY

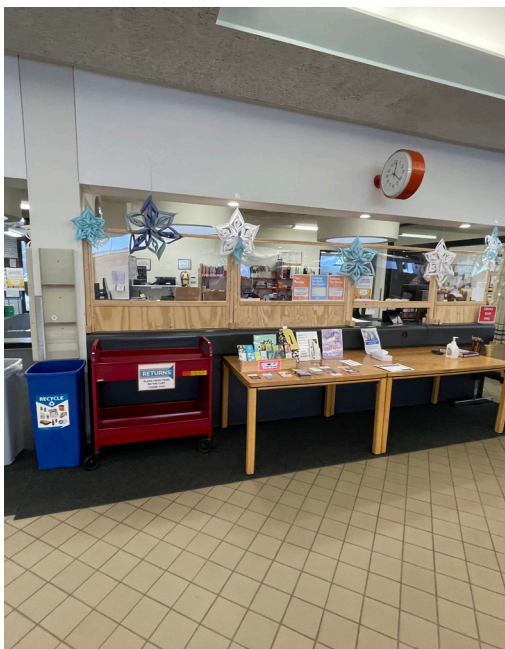
Service desk is monolithic and set back, does not provide complete vision of library, however is oriented to see entrance.

View from Service Desk

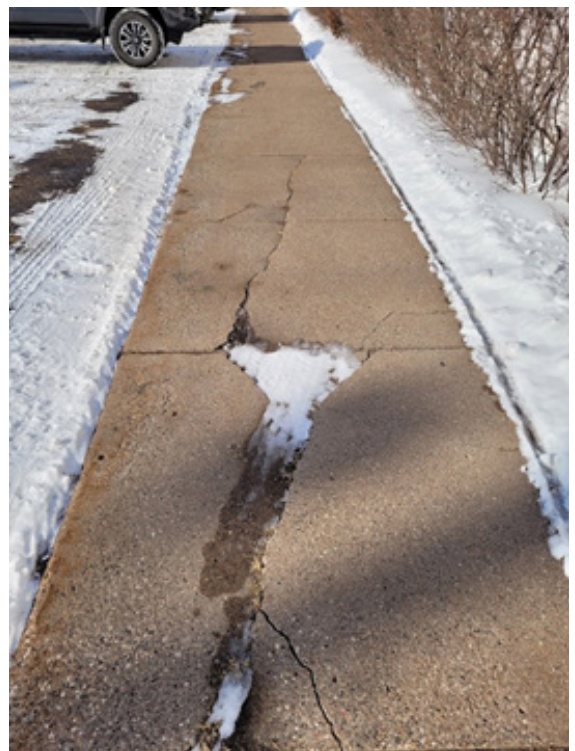
The concrete sidewalk on the south side of the building adjacent to the bituminous parking lot had significant cracking and deterioration. This concrete sidewalk should be replaced during future building improvements.

Cracked Sidewalk South of Building

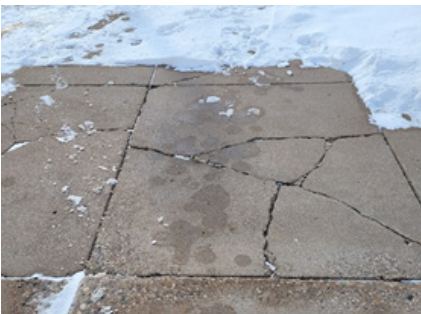
The concrete sidewalk on the west side of the library between White Bear Avenue and the structure had several noticeable heaved panels. Future improvements should identify locations of tripping hazards and replacement needs.

Cracked Sidewalk at Southwest Corner of Building

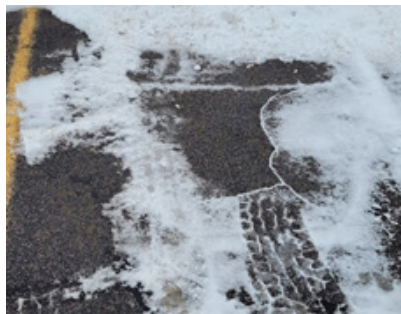
The parking lot on the south side of the site is bituminous pavement. There is no concrete curb and gutter, and the concrete sidewalk is flush with the bituminous pavement. There are approximately 20 standard parking stalls and 1 ADA parking stall. One ADA parking stall meets current code requirements for number of ADA parking stalls. A complete pavement assessment was not performed at the time of the site review as most of the parking area was covered in snow, however it appeared that there were notable full-depth cracks in the overall bituminous parking lots. It is recommended that the parking lot receive either a crack seal and new chip coat as part of any upcoming library improvements or explore the need for a full-depth replacement.

Bituminous Pavement Cracking at Staff Parking Lot

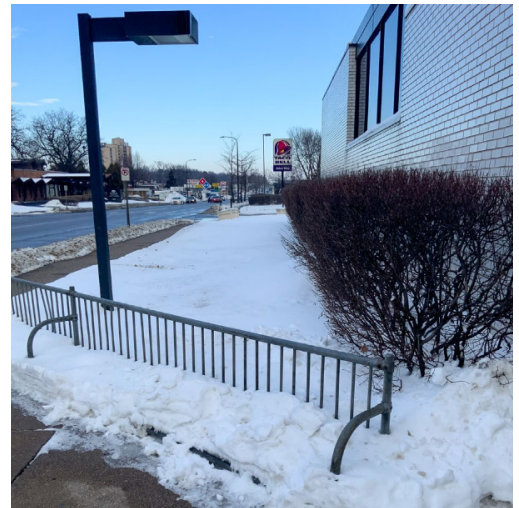
Condition: Galvanized steel, condition at base unknown, to be reviewed in spring upon clearing of snow. Does not appear to match bike racks at other library sites within project scope.

Galvanized bike rack and site light pole

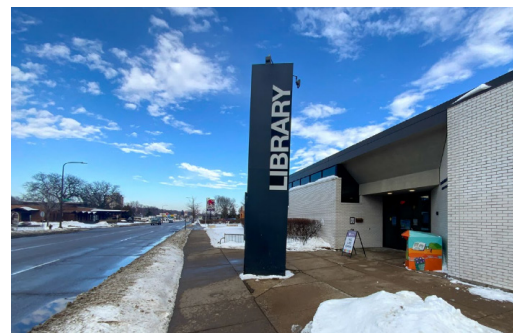
Condition: Contemporary style; slightly leaning.

Brief Summary: Sign does not identify Hayden Height by name, simply says library. Is not lit in the evening and is not standing erect. Signage does not match other library signage in project scope.

Library sign on White Bear Avenue

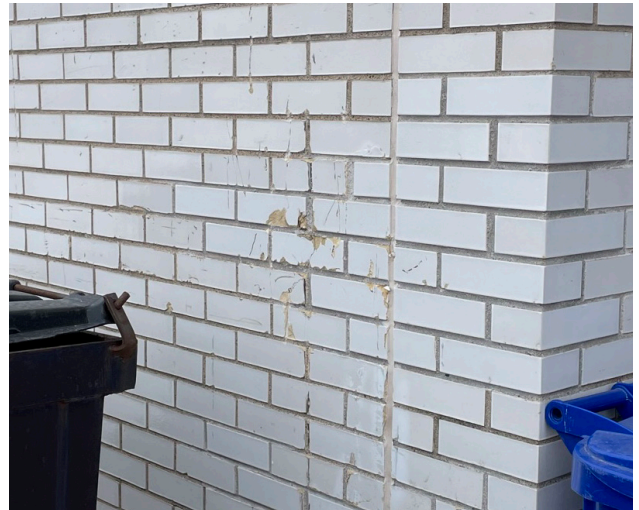
Masonry is a ceramic glazed masonry units. The majority of block is in good condition, however there is a number of bricks that have cracked or faces have spalled.

The worst condition is located near the service door due to dumpsters hitting the building.

Cracked masonry at service door

Recommendation is to replace individual bricks that have cracked and replace nearby mortar.

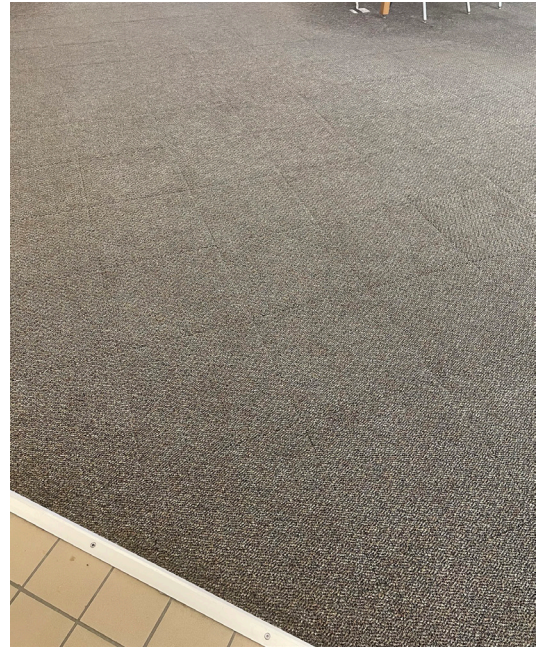
Flooring throughout is worn. The main library level is carpet has exceeded its expected life and should be replaced throughout. Tile in vestibule, entry, and around service desk is worn and should be replaced. Existing tile is inset in recessed slab that may be infilled as most modern replacement flooring options would not require same inset.

Flooring wear

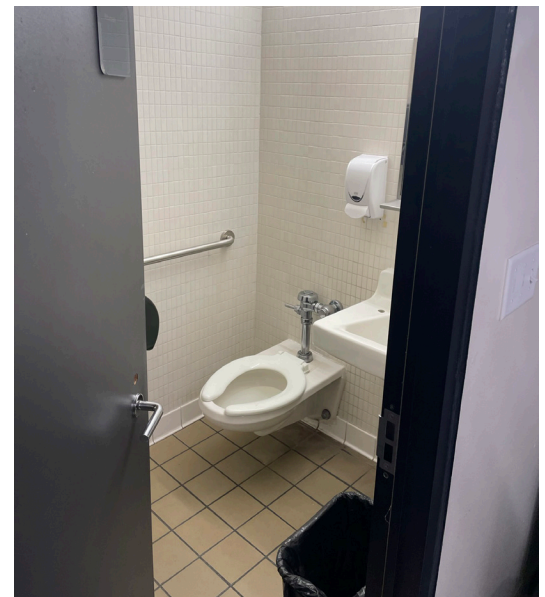
Toilet finishes are worn and beyond usable life. Staff toilets are not accessible. Toilets should receive complete replacement.

Toilet Finishes

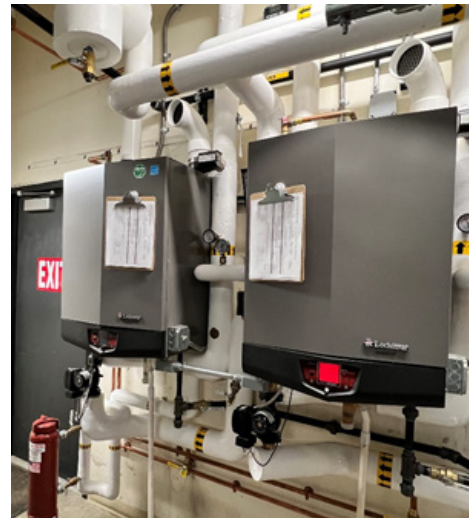
- Boilers are wall hung type and supply 180°F hydronic hot water. The boilers reduce supply temperature based on an outdoor air reset.
- The boiler vent stacks are showing signs of discoloration. The venting utilizes schedule 40 PVC, which has a maximum operating temperature of 140°F. It is recommended to replace the venting with schedule 80 CPVC or stainless steel.
- The piping serves the air handling unit, cabinet unit heaters within the vestibule, and unit heaters.

Figure 2: Boilers

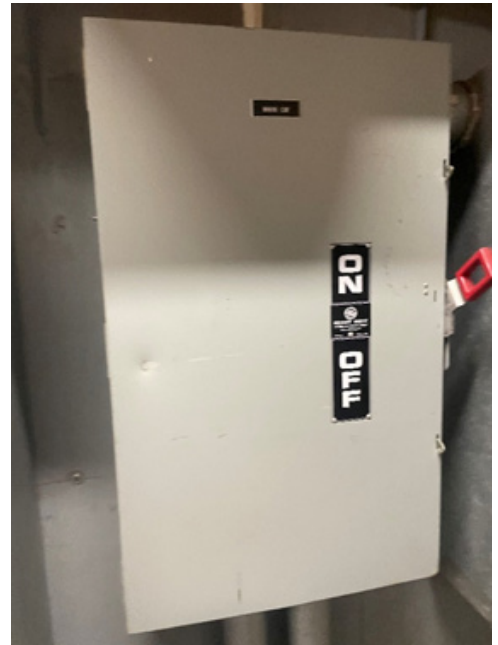
- This disconnect is labeled "MAIN SW". However, it does not appear to be service entrance rated.
- The disconnect switch feeds a main distribution panel that includes a branch circuit section and breakers that feed the HVAC equipment and two (2) branch circuit panels.

Figure 5: Main Disconnect

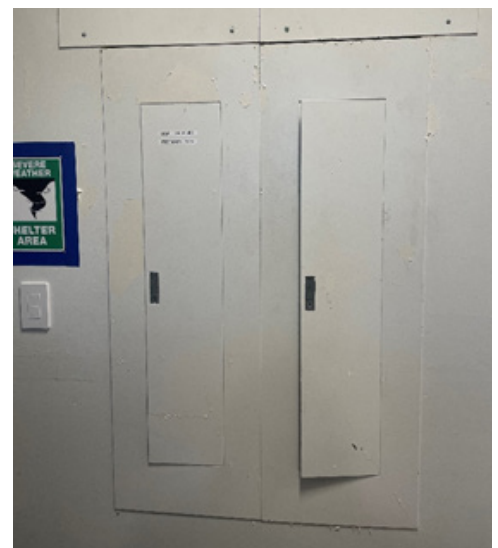
Two (2) 225-amp, 42 circuit, recessed branch circuit panelboards are located at the end of the corridor to the mechanical room. See Figure 6.

- The panelboards appear to be in good condition.

Figure 6: Electrical Panels

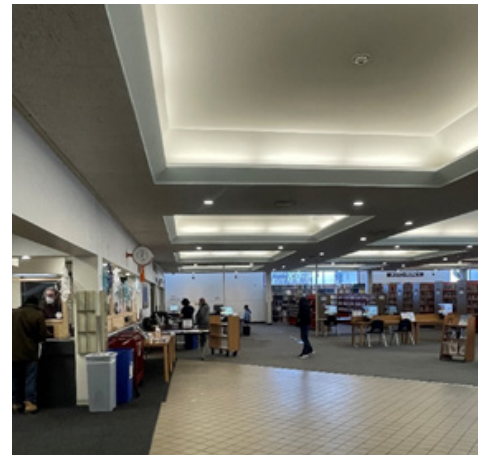
Lighting in the main library is mainly provided via a combination of square architectural coves with fluorescent strip lights and incandescent downlights. It is not known whether the fluorescent lamps and incandescent lamps have been replaced with LED lamps. See Figure 7. Some pendant fixtures and track fixtures are also located in the main library.

- The fixtures appear to be in good condition.

Figure 7: Main Library Lighting

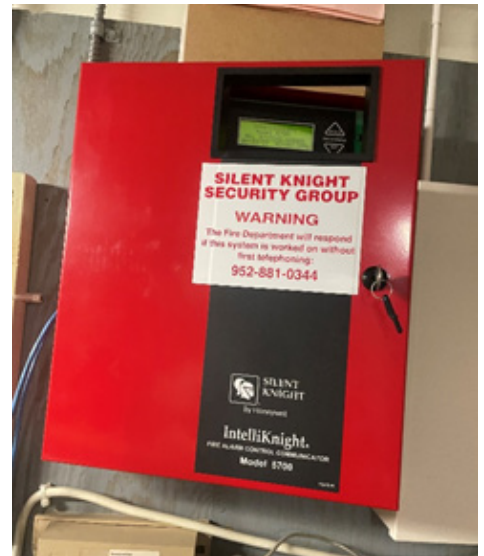
- The building fire alarm system is a Silent Knight model 5700 addressable fire alarm system.
- The system includes smoke detectors in all spaces, manual pull stations at the exits, an annunciator at the front entrance, and horn strobe annunciation units in all public spaces. The system appears to be in good condition. See Figure 9.

Figure 9: Fire Alarm Control Panel

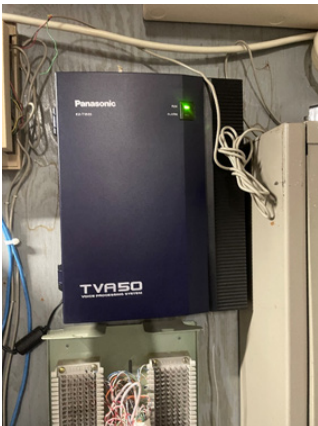
- A data rack is located in the office work room. The cabinet was locked.
- Voice/data jacks throughout the building are surface mounted and connected with surface wireway.
- The voice/data jacks appeared to be in fair condition.
- Voice PABX is a Panasonic TVA50 system.
- Voice/data cabling is mostly Category 5/5e cabling.
- Wireless LAN coverage (WLAN) should be looked at for proper coverage, as it does not appear to be adequate.

Figure 10: Voice PABX

Overhead paging system does not have adequate coverage for the space and should be replaced (if existing) or utilize fire alarm for supervised mass notification voice.

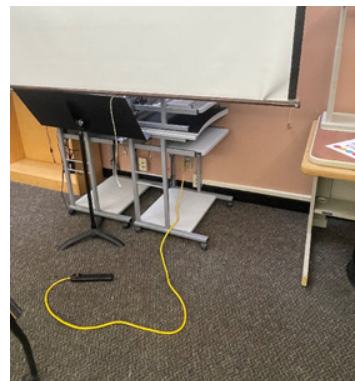
- Projection screen is in rough shape and not proper tensioning.
- Very little audio-video equipment was existing in spaces including in conference rooms. This will need to be added in a renovation for technology functionality expected by the public.

Figure 15: Damaged Projection Screen and Cabling Access
