Saint Paul Public Library

Hamline Midway Library

Pre-Design Report

May 13, 2022

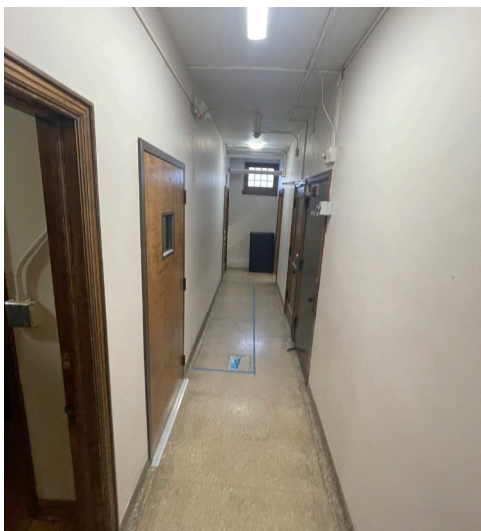
Lower level hallways are not accessible and inadequate as public spaces. Hallway from accessible entry to toilets is too narrow for passing, and hallway behind stage is a dead end corridor not visible from any other spaces and could allow someone to hide or trap someone.

Lower level dead end corridor

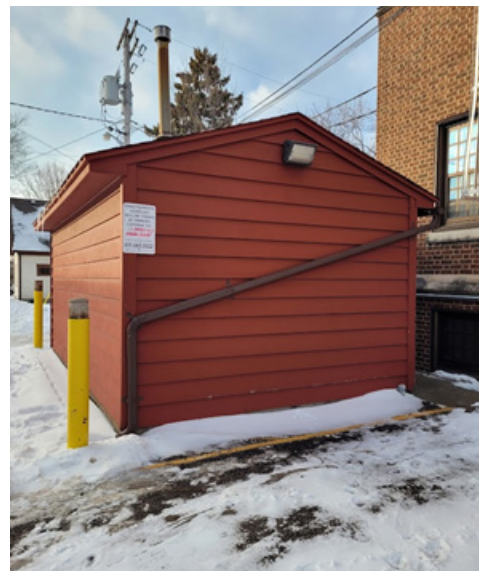
Storage building gutter system

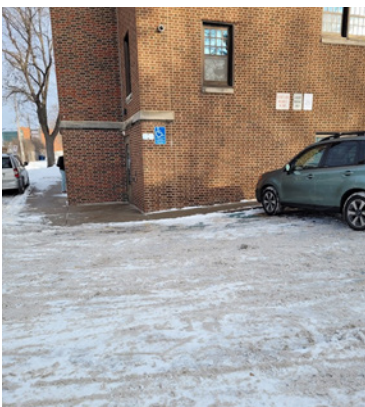
ADA Parking Stall Cross Slope

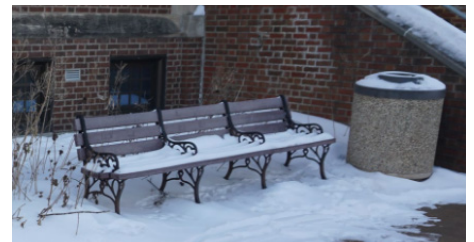
Condition: Victor Stanley bench appears to be in good condition, Unidentified bench appears to be older and in need of replacement. No apparent bench standard on site or among library sites within project scope.

Condition: Good condition; outdated style; appears to be typical trash receptacle style among all library sites within project scope.

Bench & trash receptacle

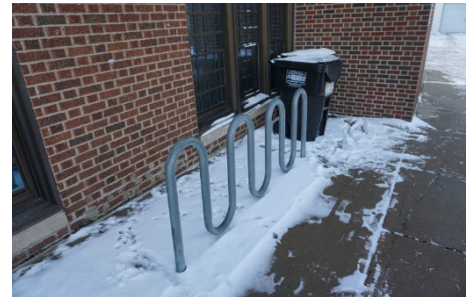
Condition: Galvanized steel, condition at base not known, to be reviewed in spring upon clearing of snow. Matches Riverview site but does not appear to be typical bike rack style among various library sites within project scope.

Standard galvanized bike rack

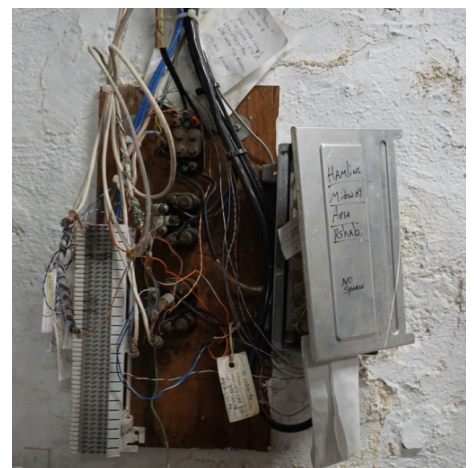
Brief Summary: Located in sub-basement. Could not confirm system type or functionality with staff.

Irrigation control unit

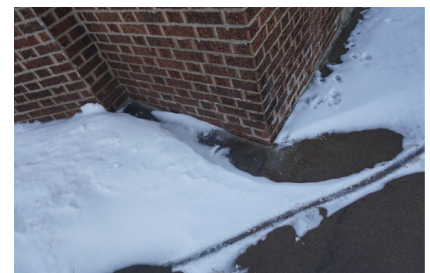
Brief Summary: Interior analysis of auditorium space indicates water intrusion and damage where visible ice buildup occurs at exterior NW corner of building on sidewalk.

Ice buildup at Northwest corner of building

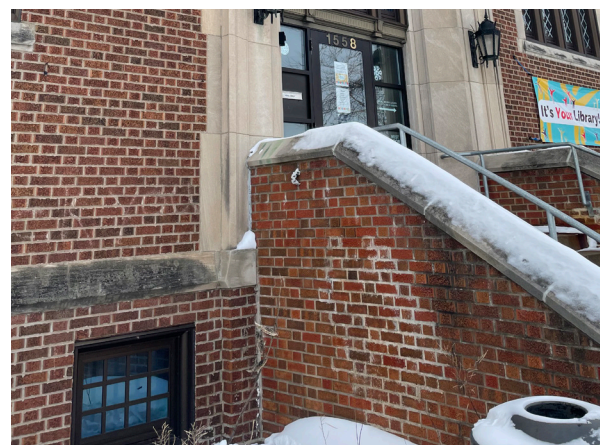
Entry stair was replaced in the 1980s but is in poor conditions. Stair risers are concrete and have chipped. Masonry shows signs of deterioration. Railing was previously removed and post embeds rusted and have stained stairs. Stairs should be demolished and replaced.

Masonry at stairs

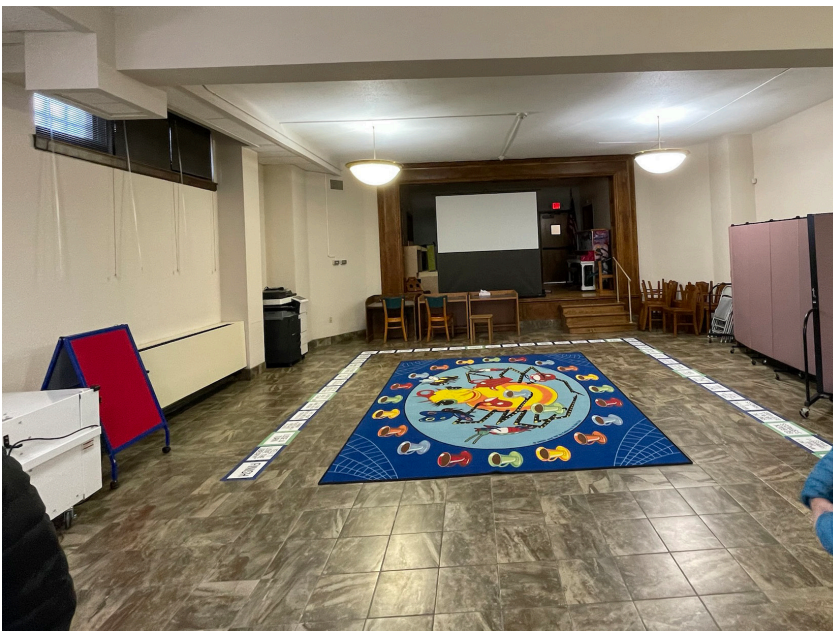
Meeting Room

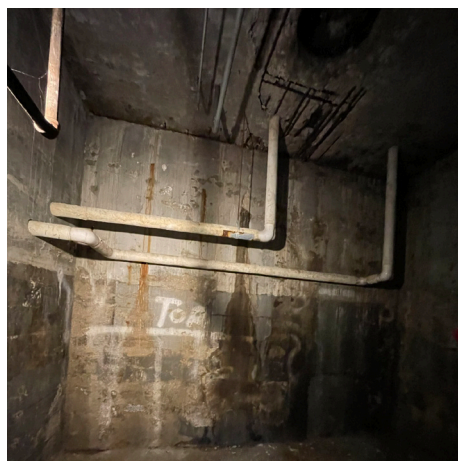
Inside the original fuel room and ash room on the east side of the building there is significant deterioration on the underside of the concrete slab over these rooms, as well as signs of water infiltration. These rooms are located outside of the building footprint above. A piece of mechanical equipment is sitting on this slab. The existing reinforcing in the slab is visible, and there is corrosion of the existing rebar. See the attached photos. The concrete slabs over these rooms need to be repaired and/or removed

Exposed Rebar in slab

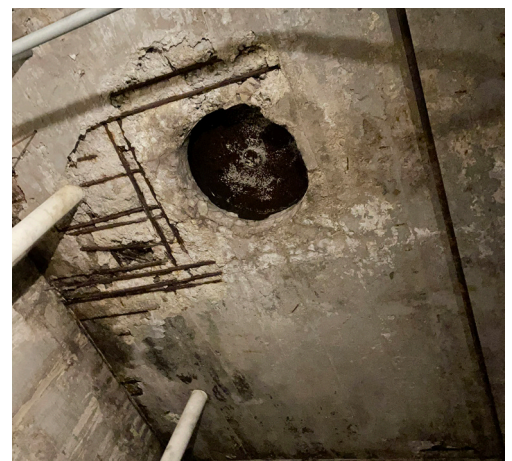
Exposed Rebar in slab

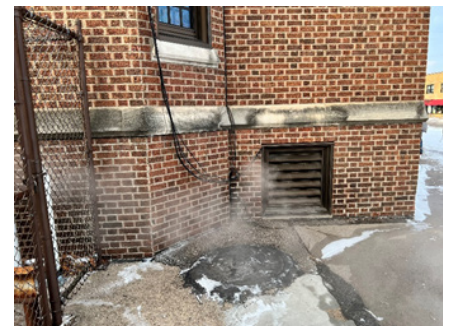
Figure 2: Boiler flue exhaust entering combustion air intake

- During the onsite assessment, boiler flue gas was noted to be recirculating back into the building, and combustion air intakes. This was due to wind direction and speed. The separation of the intake and flues meet code requirements. See Figure 2.

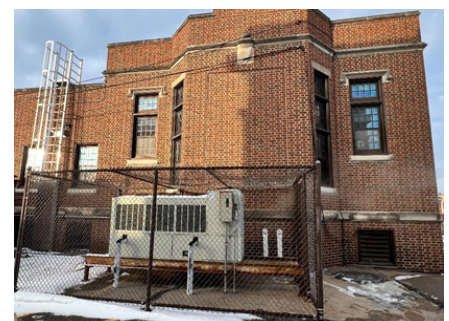
Figure 4: Air-cooled chiller

The building is conditioned with an air-cooled chiller. The unit is located on the east side of the building. See Figure 4. The unit has approximately 20 tons capacity.

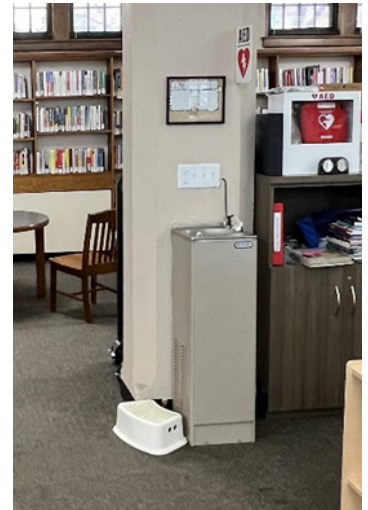
Figure 5: Water Cooler

- One (1) non-ADA compliant water cooler is located on the upper level. See Figure 5.
- Restroom fixtures are dated and in need of replacement, including water closets, flush valves, and lavatories. Water closets are floor mounted, flush valve type.
- The breakroom consists of residential type fixtures (coffee maker and microwave) and sink. It was noted this space does not contain a heat source, and risks freezing domestic piping.

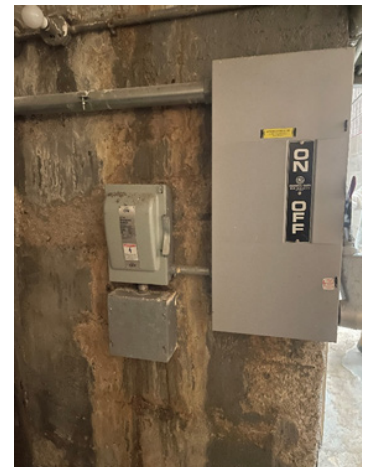
Figure 6: Main Disconnect

A 200-amp main service disconnect switch is located within the coal storage room. See Figure 6.

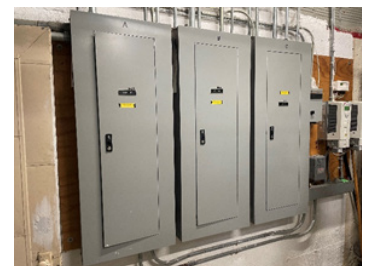
Figure 7: Electrical Panels

The disconnect switch feeds three (3) main lug only 200-amp panelboards located within the boiler room. See Figure 7.

- These panelboards appear to be in good condition.

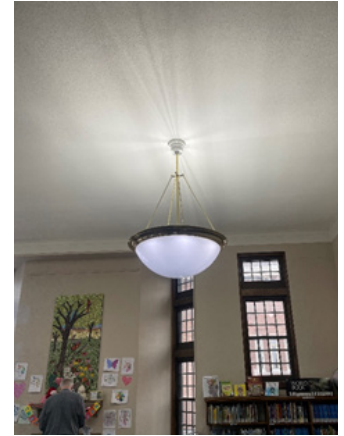
Figure 8: Main Library Pendant Fixture

Lighting in the main library is provided via large semicircular pendant fixtures. On site staff indicated the lamps for these fixtures have been replaced with LED lamps. See Figure 8.

- These fixtures appear to be in good condition.

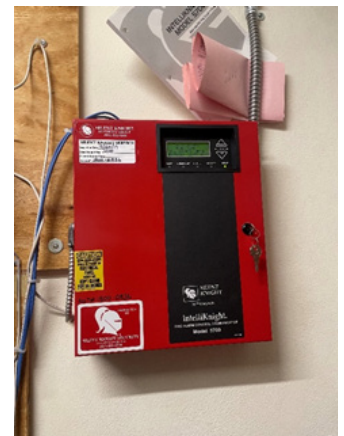
Figure 9: Fire Alarm Control Panel

The system includes smoke detectors in all spaces, manual pull stations at the exits, an annunciator at the front entrance, and horn strobe annunciation units in all public spaces. The system appears to be in good condition. See Figure 9.

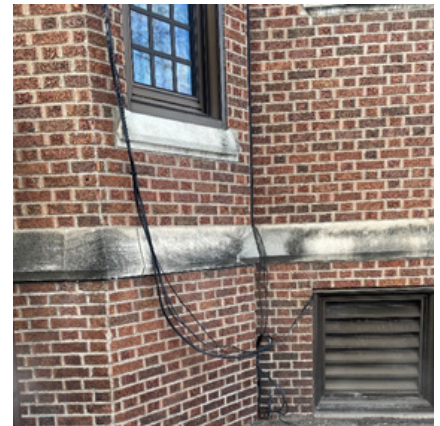
- Voice PABX is a Panasonic TVA50 system.
- Voice/data cabling is mostly Category 5/5e cabling.
- Wireless LAN coverage (WLAN) should be looked at for proper coverage.
- The voice/data jacks appeared to be in fair condition. Data cabling is not typically supported adequately with cabling zip-tied together or attached to conduit.
- The telecommunications lines enter the building from a utility pole at the south side of the building, and are routed on the surface of the building. This wiring is susceptible to damage. See Figure 12.

Figure 12: Exposed Exterior Low Voltage Wiring

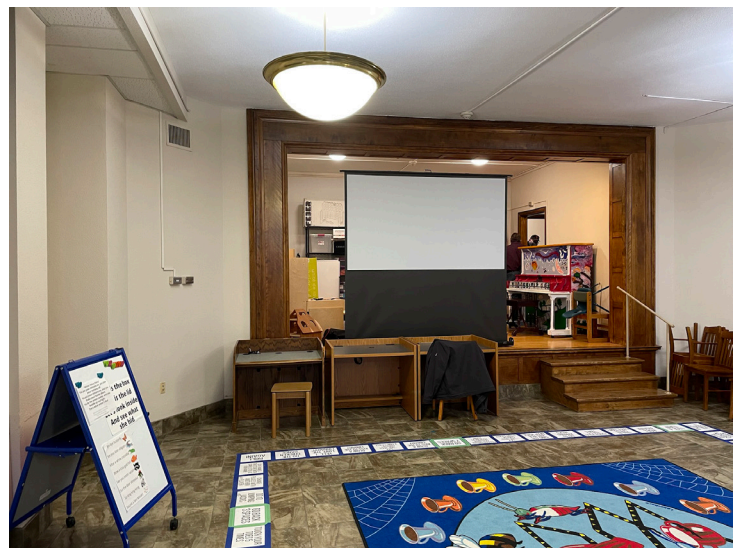
The measured ANLs were higher than industry standards for library ambient noise levels, but primary noise sources were the air purifiers above the main entry door, and the air purifier and dehumidifier in the Auditorium which are a temporary solution.

Temporary portable filter makes hearing presentations in auditorium difficult
