Saint Paul Public Library

HAYDEN HEIGHTS

Pre-Design Report

HAYDEN HEIGHTS LIBRARY

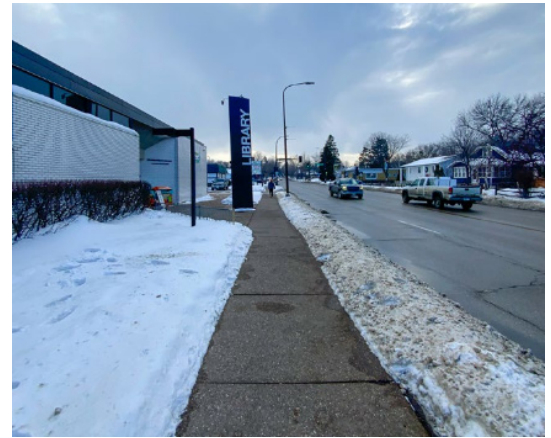
Sidewalk along White Bear Avenue

The concrete sidewalk on the west side of the library between White Bear Avenue and the structure had several noticeable heaved panels. Future improvements should identify locations of tripping hazards and replacement needs.

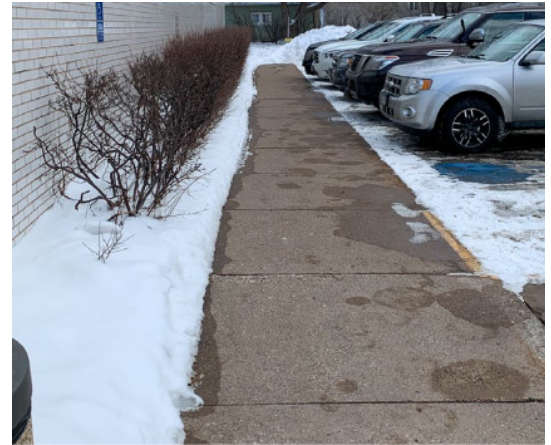
Sidewalk along parking lot

The concrete sidewalk on the south side of the building adjacent to the bituminous parking lot had significant cracking and deterioration. This concrete sidewalk should be replaced during future building improvements.

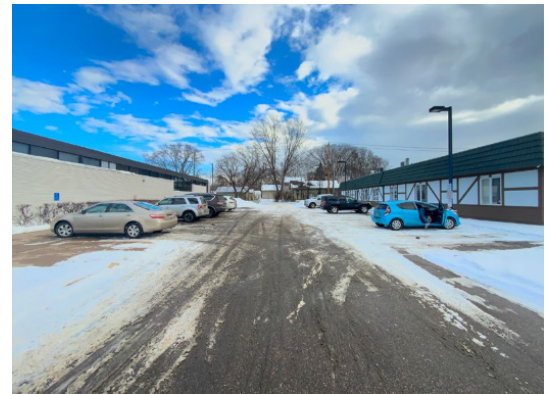
Parking lot

The parking lot on the south side of the site is bituminous pavement. There is no concrete curb and gutter, and the concrete sidewalk is flush with the bituminous pavement. There are approximately 20 standard parking stalls and 1 ADA parking stall. One ADA parking stall meets current code requirements for number of ADA parking stalls. A complete pavement assessment was not performed at the time of the site review as most of the parking area was covered in snow, however it appeared that there were notable full-depth cracks in the overall bituminous parking lots. It is recommended that the parking lot receive either a crack seal and new chip coat as part of any upcoming library improvements or explore the need for a full-depth replacement.

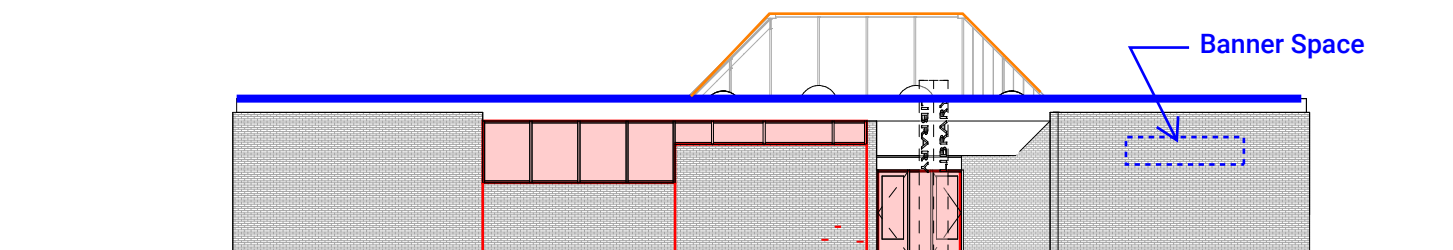
West Elevation

Masonry is a ceramic glazed masonry units. The majority of block is in good condition, however there is a number of bricks that have cracked or faces have spalled.

Recommendation is to replace individual bricks that have cracked and replace nearby mortar.

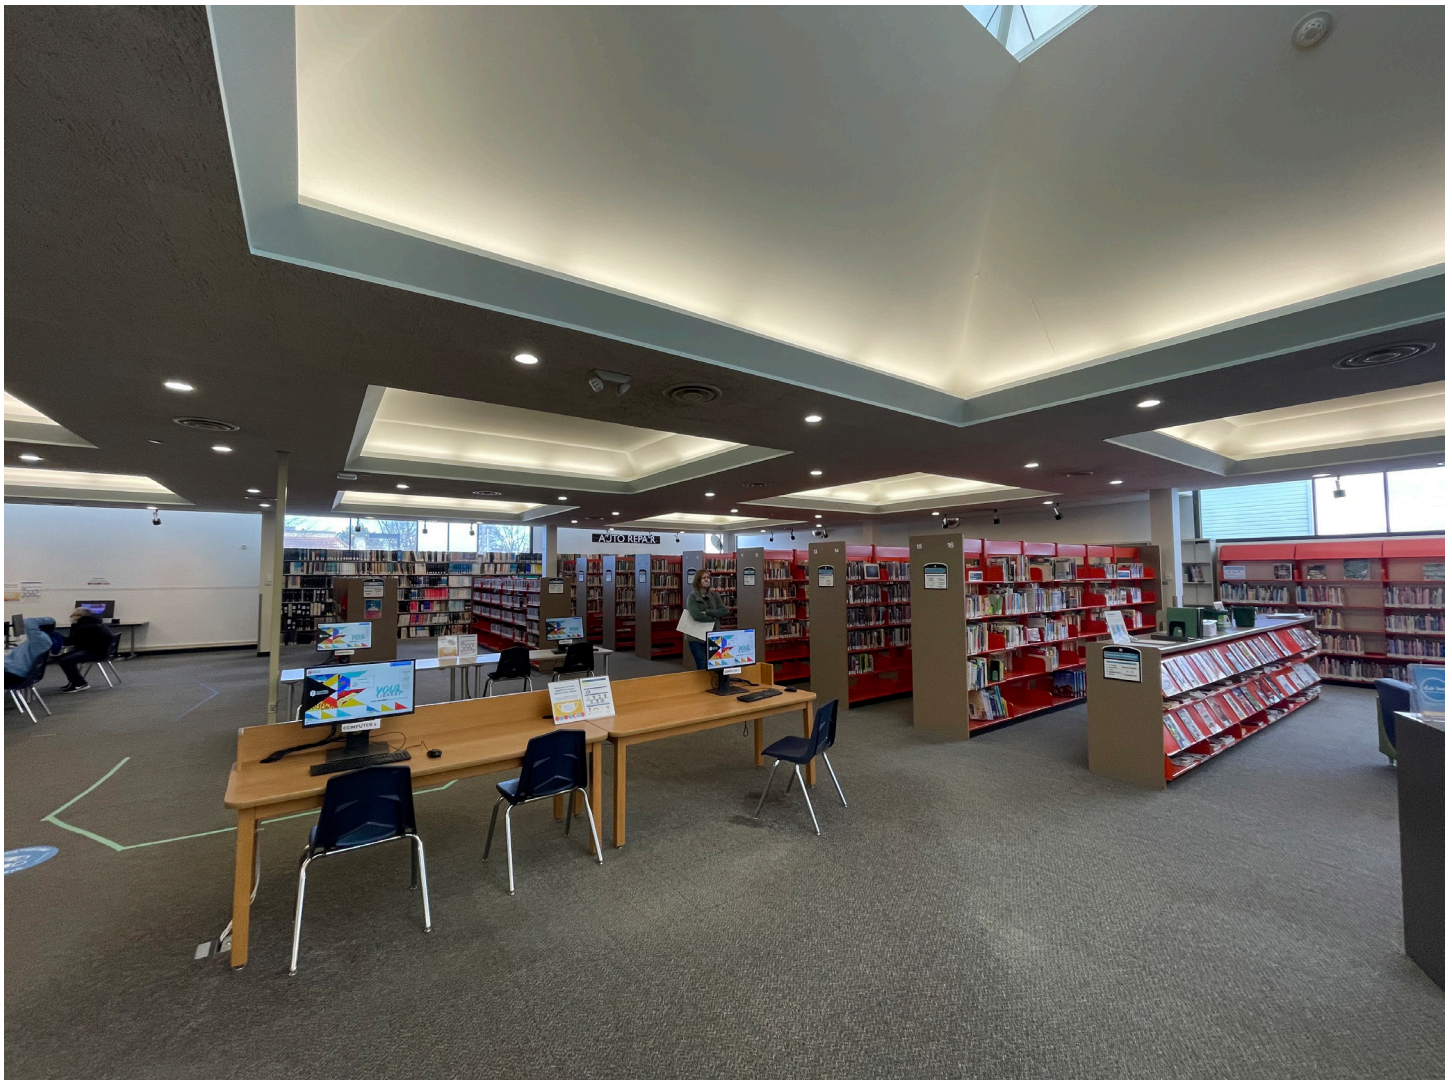
Main Reading Room

Flooring throughout is worn. The main library level is carpet has exceeded its expected life and should be replaced throughout. Tile in vestibule, entry, and around service desk is worn and should be replaced. Existing tile is inset in recessed slab that may be infilled as most modern replacement flooring options would not require same inset.

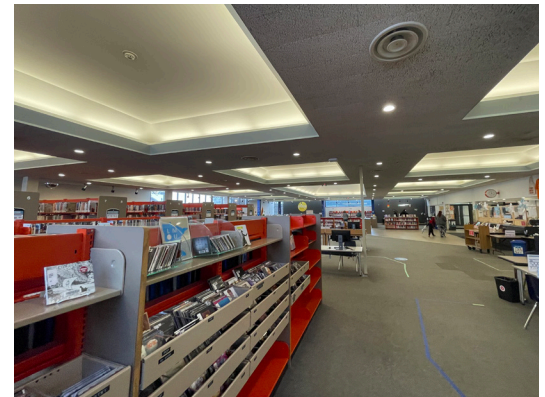
Existing Media shelving

Shelving is modular and similar to what replacement would be specified now. Shelving is orange which, depending on direction of project, may be an opportunity for a design feature. Surrounds are plastic laminate which has shown wear and are dated but could be replaced without replacing the shelving. Media shelving is worn and should be replaced.

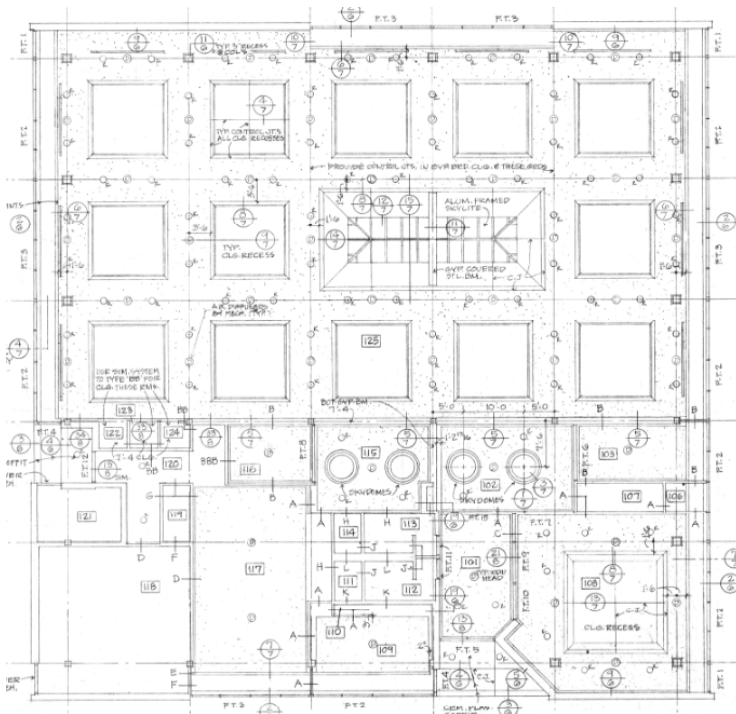
Reflected Ceiling Plan

There were some minor cracks in the gypboard ceiling in the skylight area. The cracks are small and limited in an isolated area. In our opinion there is not a structural concern, and the cracks are due to minor deflection and temperature differential movement in the gypboard ceiling adjacent to the skylight.

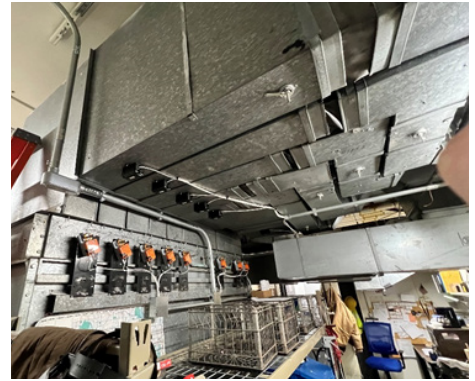
Figure 1: AHU - Multizone Dampers

- One air handling unit (AHU) provides mixed air throughout the building. It is controlled through multizone dampers, with a hot / cold deck. See Figure 1. This unit also has onboard needlepoint bipolar ionization.
- The AHU utilizes MERV 13 filters.

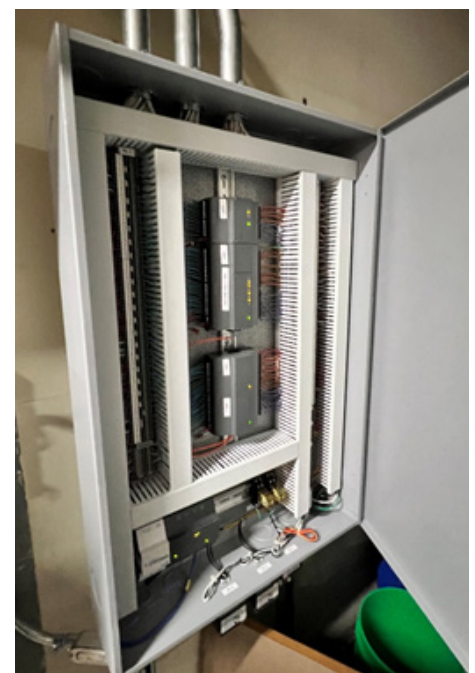
Figure 3: Building Automation System

The building automation system (BAS) has been upgraded from pneumatic to digital controls. Controls are proprietary by Johnson Controls. Refer to Figure 3.

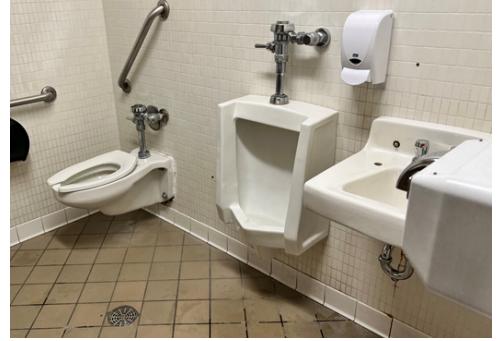
Figure 4: Restroom Fixtures

- Restroom fixtures are in good condition. See Figure 4. Water closets are wall mounted, flush valve type.

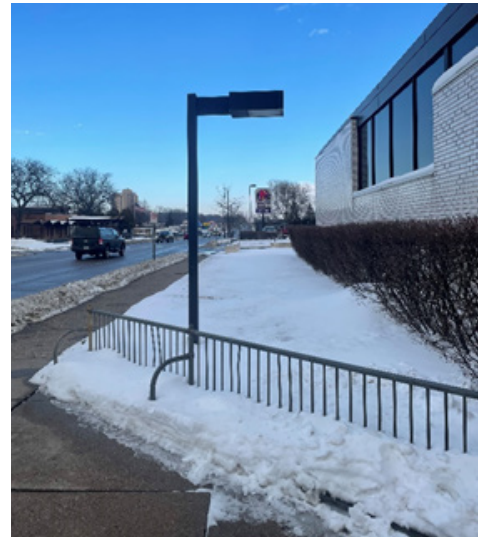
Figure 8: Short Shoebox Fixture

The front sidewalk of the library is illuminated by several shoebox fixtures mounted to very short poles. See Figure 8.

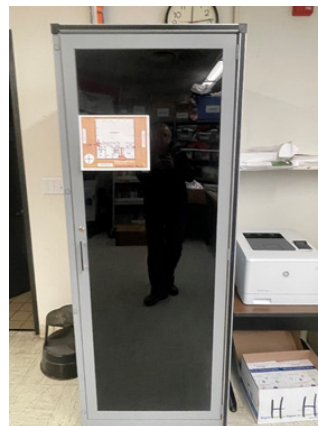
Figure 12: Data Cabinet

- A data rack is located in the office work room. The cabinet was locked.
- Voice/data jacks throughout the building are surface mounted and connected with surface wireway.
- The voice/data jacks appeared to be in fair condition.
- Voice PABX is a Panasonic TVA50 system.
- Voice/data cabling is mostly Category 5/5e cabling.
- Wireless LAN coverage (WLAN) should be looked at for proper coverage, as it does not appear to be adequate.

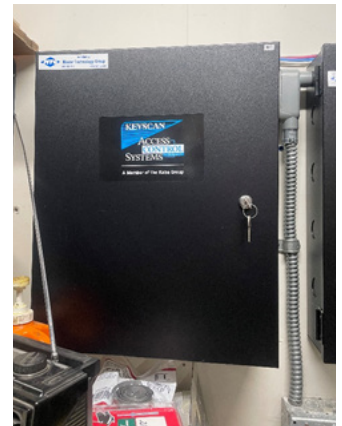
Figure 13: Access Control System

was the only card reader observed.
